CASE HISTORY

Ref. No.: CH/18/07/V-05-17-011	Year: 2017-18
Name of the Work: Rock fall slope Mitigation measures for hill slopes at Shri RamLaxman Gad Mandir Taluka Ramtek, District Nagpur	
Client: Maccaferri Environmental Solutions Pvt Ltd	
Main Client: Public Works Department, Nagpur.	
Site Address: Shri RamLaxman Gad Mandir Taluka Ramtek, District Nagpur	
Type of Work: : Rock fall Mitigation and Slope Stabilization Works	
Start Date: July 2017	Completion Date: May 2018
Value of Work: Rs. 60,00,000(approx.)	
Nature of work:	<p>Rock fall Mitigation and slope stabilization work had to be carried out on a hilly terrain around the temple using HEA and SGMO nets and soil nails.</p> <p>Specifications of the area was such that :</p> <ul style="list-style-type: none"> • Minimum height = 07m • Maximum height = 19m • Quantity of work done = 8500sqm • Stretch length = 60m • Minimum Nail length =4m • Maximum Nail length =8m <p>The rock present on site was observed to be Quartzite in nature with Miceaous ferrous content. But since the crack width was more than 300mm at certain locations it was evident that drill length for anchors would be more. The temple was founded on the rock which faced

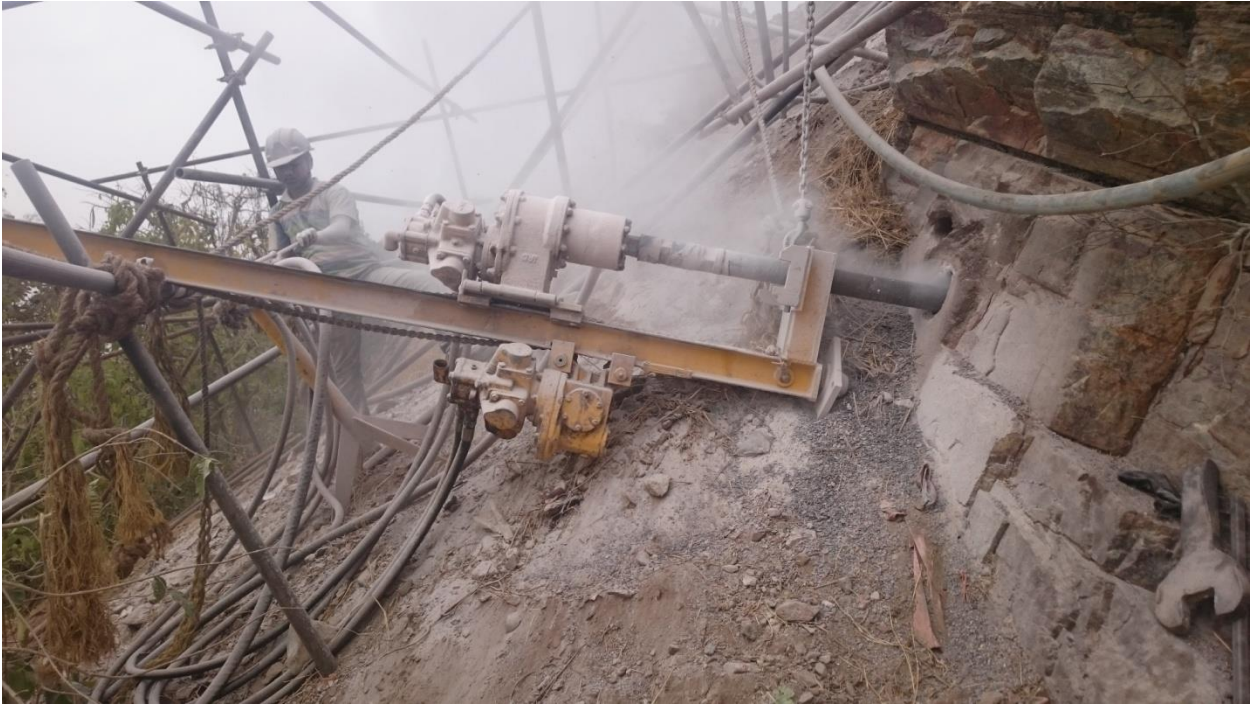
Drilling of rock using Special costumised Drifter 75mm dia Drillbit

The drilling was carried out for 8m depth in locations which were vulnerable to failure prone zones. Remaining stabilization was done with 4m/6m drill anchors.

Due to presence of Magneferrous Quartzite the drilling into the rock was exhaustive. Hence specific equipments were developed and reinvigorated. This changes in equipments and increased capacity of compressor the performance of drilling activity was improved. Due to the adaptation of upgraded machines the consumption of drill bits was also decreased and rate of drilling was increased.

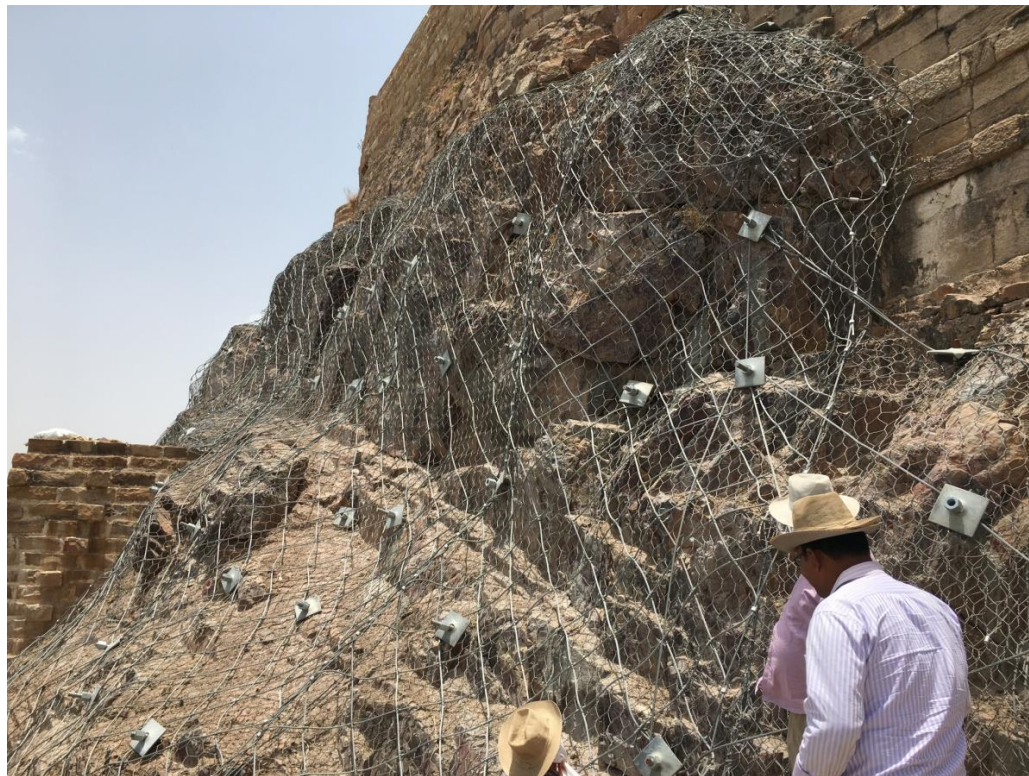
Slope stabilization work using HEA and SGMO nets

Steel grid mono oriented was used in construction with high energy absorption panels. This would prevent the rock fall and support the rock stability.

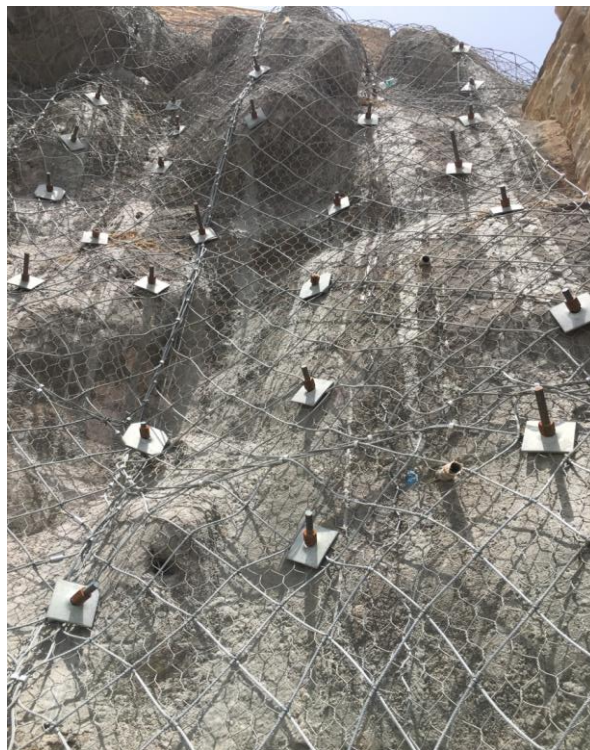
Soil nailing work to stabilize slope and rock fall mitigation

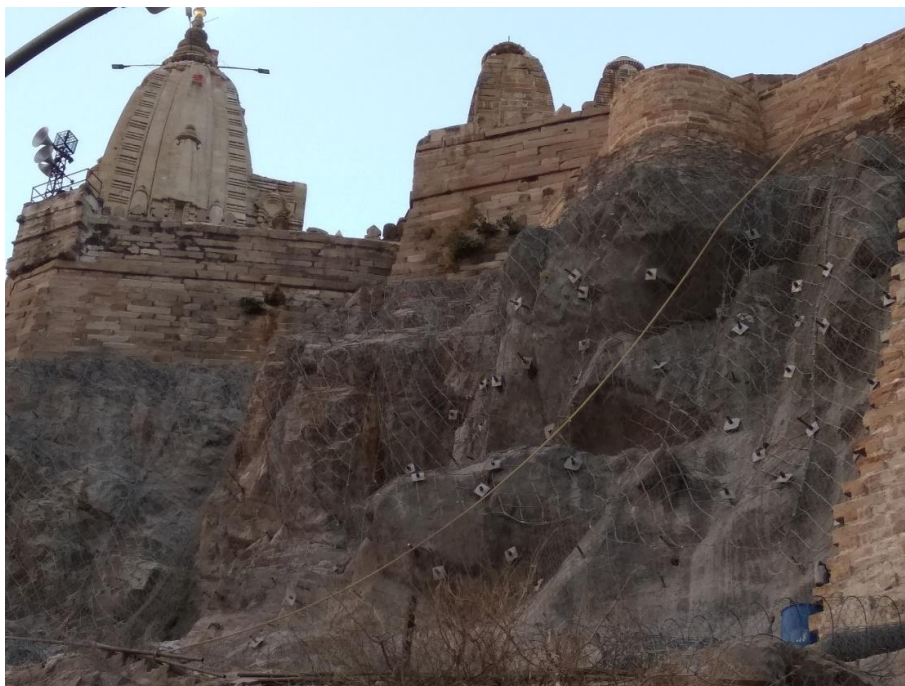
Side view of temple where work is done

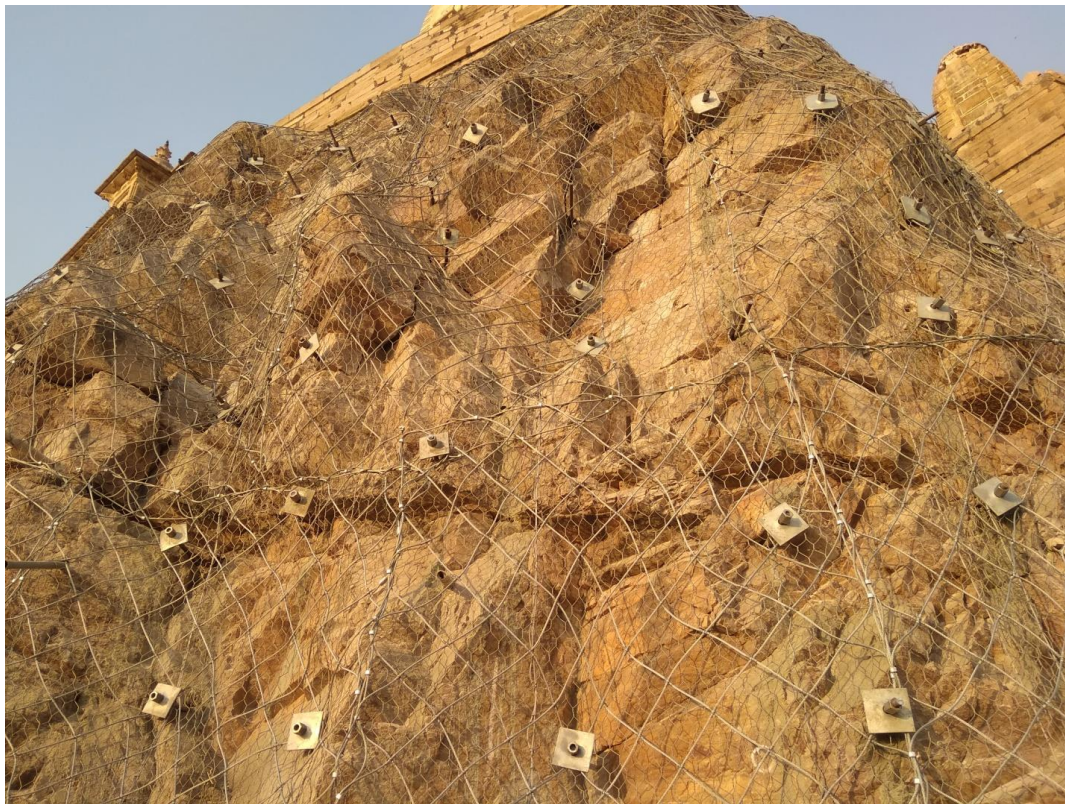
Clear view of net along with soil nails

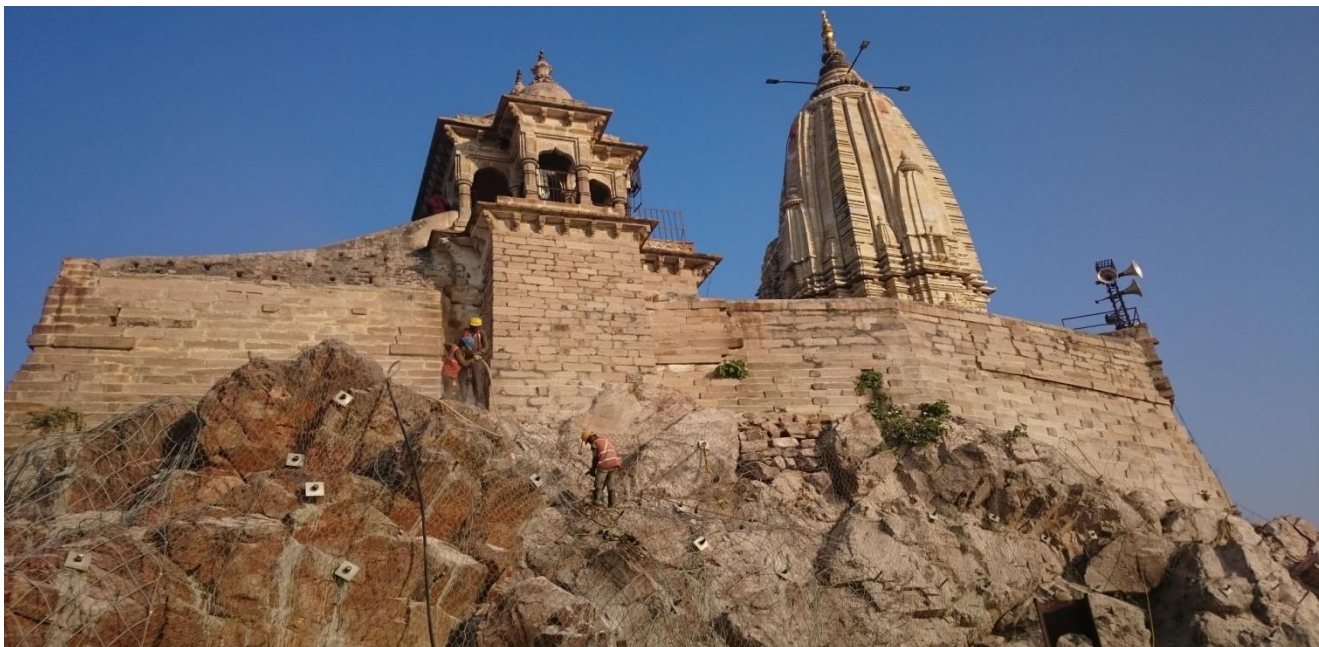
Side view of Temple where work is in progress
